**APPENDIX I**  
**REPORT ON THE STATUS AND IMPLICATIONS OF**  
**SEISMIC HAZARD STUDIES AT LANL**

## **Status and Implications of Seismic Hazard Studies at LANL**

Prepared By: Larry Goen, ESA-EA

December 17, 1998

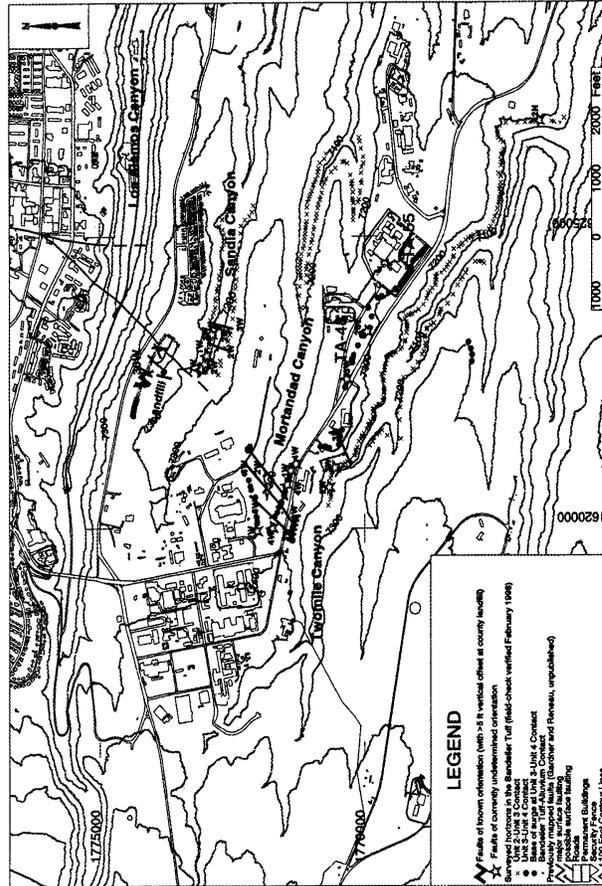
The stratigraphic survey (Ref. 1) for TA-55 is complete and found no evidence for existing faults. Thus the area is not susceptible to surface rupture from earthquakes.

In Reference 1, results are presented of high-precision geologic mapping in the vicinity of TA-55 that has been done to identify parts of the southern portion of the Rendija Canyon fault, or any other faults, with the potential for seismic surface rupture. To assess the potential for surface rupture at TA-55, an area of approximately 3 square miles that includes the Los Alamos County Landfill and Twomile, Mortandad, and Sandia Canyons has been mapped in detail.

**Figure 2 – Map of Faulting in TA-55 Area (Ref. 1)**  
Numbers and letters adjacent to faults indicate the amount of displacement (in feet) and sense of displacement (e.g., 4W = 4 feet of displacement down to the west).

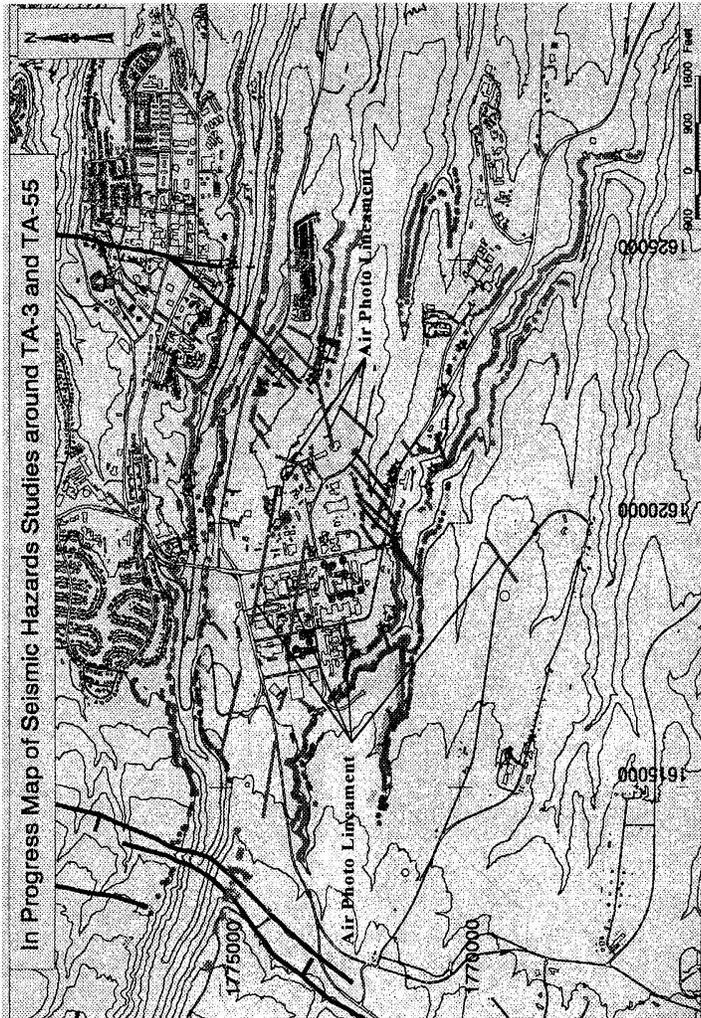
The areas surveyed in the data collection portion of this study are indicated in Figure 3. Along with the survey locations, Figure 3 also depicts the location of linear features found in the examination of air photos dating to the 1940's. The linear features could indicate the location of faults, but could also indicate other linear features such as fences trails and roads. These linear features are being used as guides in the data analysis currently underway. As the data analysis progresses, it is expected that some of the air photo lineaments will be designated faults while others will be removed from the map.

Although data analysis is in progress, preliminary findings indicate faulting is present in the TA-3 area. The majority of the faults is in the southeastern area of TA-3. These faults have vertical offsets in the range of 1 to 10 feet.

**Figure 3 – In Progress Map of Fault Location in TA-3**  
 Unless indicated as “Air Photo Lineament” (purple lines), lines indicate faults of known orientation. Stars represent faults of unknown orientation. Dots indicate surveyed points of stratigraphic contacts.

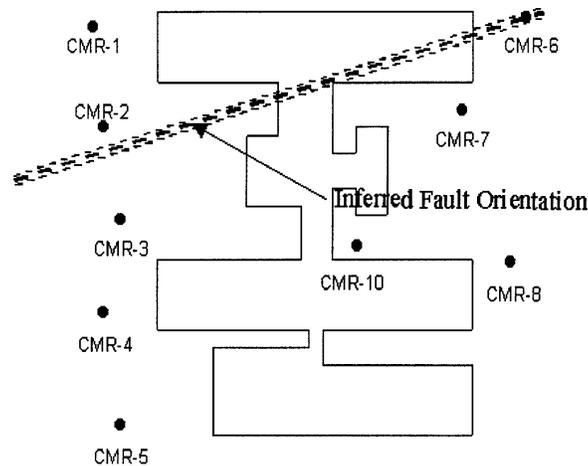
Figure 4 – Plan View of CMR Building With Inferred Location of Fault

Analysis (Ref. 4) of the data obtained indicates that a fault is present at the CMR Building. Its location and inferred orientation are shown in Figure 4. The fault is contained within the core obtained from the CMR-6 and can be inferred to occur between the CMR-2 and CMR-3 locations. This orientation is consistent with one of the air photo lineaments shown in Figure 3. The total displacement of Unit 3 in the CMR-6 core is approximately 8 feet.

Based on this investigation, it can be concluded that the CMR Building site has, in the past, been impacted by fault rupture. However, as discussed later in this report, the probability of an earthquake causing significant surface displacement at this site in the future is small.

The discovery of a fault under the CMR Building has an impact on decisions concerning upgrades and future uses for the facility. From the seismic perspective, the question which needs to be assessed is whether or not it is prudent to upgrade the structure to resist ground motion loads when the probability of damaging surface rupture is near the performance goal level for the facility. While it is possible to upgrade to resist the forces/displacements caused by permanent ground deformation, the upgrade costs would increase substantially. It should be noted that this site would not be considered adequate for a new nuclear facility.

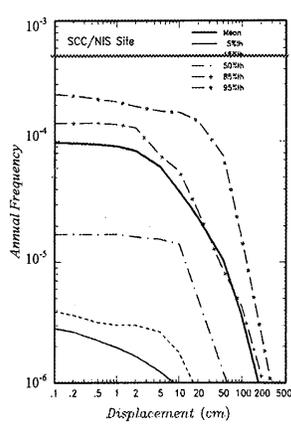
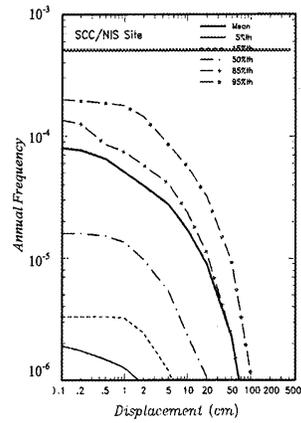
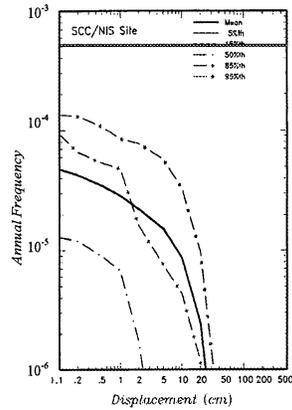
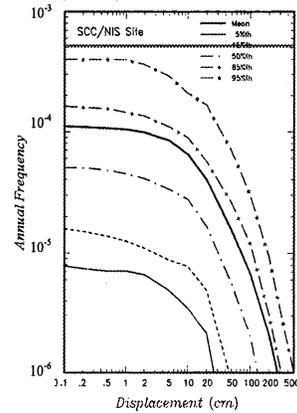
The results, summarized in Table 2, show that for annual frequencies of  $10^{-4}$  or larger, surface rupture is minimal or nonexistent. The hazard curves developed for the two sites are shown in Figures 5 and 6. Hazard curves that investigate the sensitivity of the three main faults being connected or not are shown in Figure 7.

Figure 5a – Case 1a:  
Distributed Faulting w/ 9m  
Cumulative Displacement

Figure 5b – Case 1b:  
Distributed Faulting w/ 1m  
Cumulative Displacement

Figure 5c – Case 1c:  
Distributed Faulting w/ no  
Cumulative Displacement

Figure 5d – Case 2:  
Principal Faulting w/ 15m  
Cumulative Displacement

Figure 5 – Surface Rupture Hazard Curves for the SCC/NIS Site (Performance Goal for PC 2 Facilities is  $5 \times 10^{-4}$ )

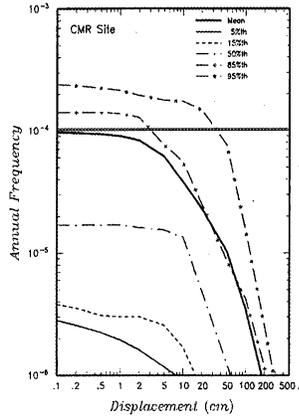
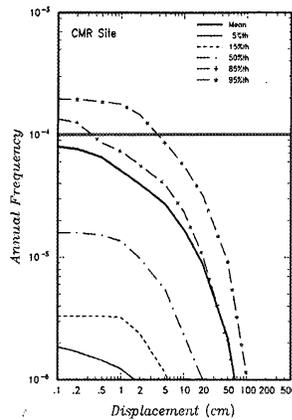
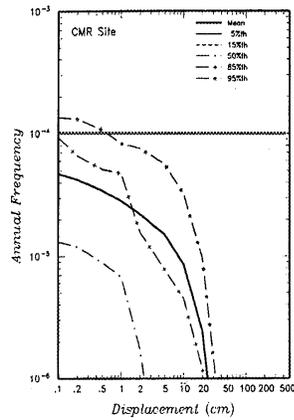
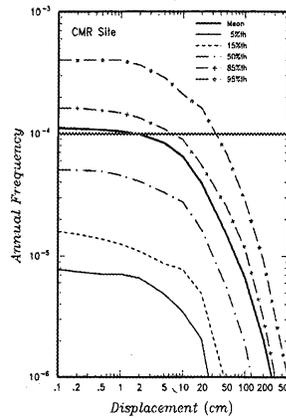
Figure 6a - Case 1a:  
Distributed Faulting  
9m Cum. Displacement

Figure 6b - Case 1b:  
Distributed Faulting  
1m Cum. Displacement

Figure 6c - Case 1c:  
Distributed Faulting  
No Observable Displacement

Figure 6d - Case 3:  
Principal Faulting  
15m Cum. Displacement

Figure 6 – Surface Rupture Hazard Curves for the CMR Building Site (Performance Goal for PC 3 Facilities is  $1 \times 10^{-4}$ )

However, if the worse case assumption is made that this is a principal fault and that all three faults are connected, the estimated offset from Figure 6 for the PC 3 performance goal is approximately 10 centimeters (4 inches). A displacement of this magnitude can cause significant cracking in a concrete shear wall structure such as those used in the construction of the CMR Building. This cracking could result in a loss of confinement.

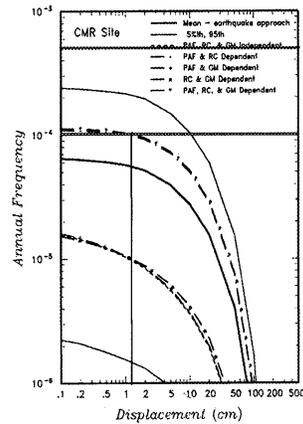
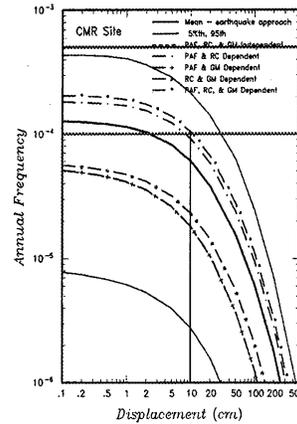
Figure 7a – Case 1b  
Distributed Faulting w/ 1m  
Cumulative Displacement

Figure 7b – Case 3:  
Principal Faulting w/ 15m  
Cumulative Displacement

Figure 7 – Surface Rupture Hazard Curve Sensitivity Results (Illustrates the effects of assuming fault dependency on hazard curves.)

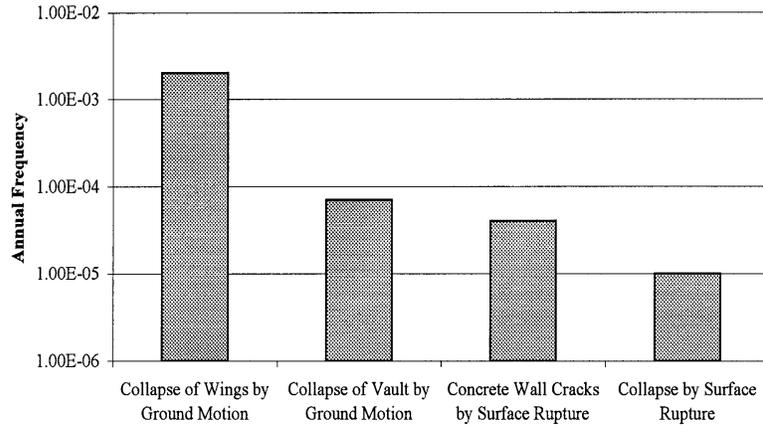
It can be shown (Ref. 12) that the annual probability of seismic induced failure, based on ground motion associated with an earthquake, is about  $2 \times 10^{-3}$  for most areas of the CMR Building. The exceptions to this is the vault that has an annual probability of seismic induced failure, again, based on ground motion, of about  $7 \times 10^{-5}$ , and the floor wells which have yet a lower probability of failure. The significance of this information is that ground motion could cause a loss of confinement for most areas of the CMR Building at frequency that is at least 20 times greater than surface rupture.

Based on current available information, the fault under the CMR site is a subsidiary fault. As a result, any movement on the fault is likely to be small and would be a result of a large (Magnitude 6 to 7) earthquake on the Rendija Canyon or the Pajarito fault. Such earthquakes are low probability events. In Figure 9 the estimated annual frequency of damage caused by ground motion is compared to the annual frequency of damage caused by surface rupture. This figure illustrates that damaging surface rupture is far less likely to occur than damaging ground motion.

**Figure 9 – Frequency of Seismic Induced Damage at CMR Building**
