Management of Time Sensitive Chemicals (I): Misconceptions Leading to Incidents

Jim Bailey (Bechtel Jacobs, Oak Ridge), David Blair (Heritage-ETS), Lydia Boada-Clista (DOE Ohio Field Office), Dan Marsick (DOE-EH), David Quigley (Y-12), Fred Simmons (SRS), Helena Whyte (LANL-HSR-5)

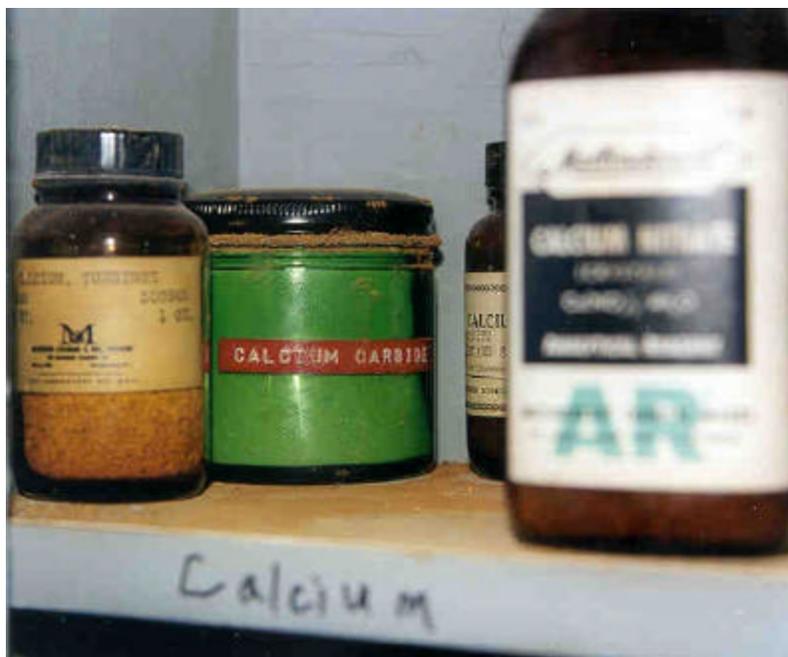
A commonly made error is to store chemicals in containers that are incompatible for long term storage. Figure (1) shows calcium carbide stored in a glass container with a bulging metal lid (16). The screw on lid present on this container was manufactured from metal with a high brass content. Upon prolonged storage, the calcium carbide reacted with moisture in the air to produce acetylene gas. The acetylene gas reacted with copper and other heavy metals present in the high brass content lid. The product of this reaction was heavy metal acetylides which were now located in the threads of the cap. Heavy metal acetylides of this type are extremely unstable and are prone to explosion. Simply the act of twisting the lid or bumping the container could provide enough energy to initiate an explosion.

Figure 1- Calcium Carbide Stored In a Glass Container With a High Brass Content Metal Lid. Note the Bulging Lid Indicating Acetylene Gas Inside The Container.
