OPERATING EXPERIENCE SUMMARY

U.S. Department of Energy

OE Summary 2003-10

May 19, 2003

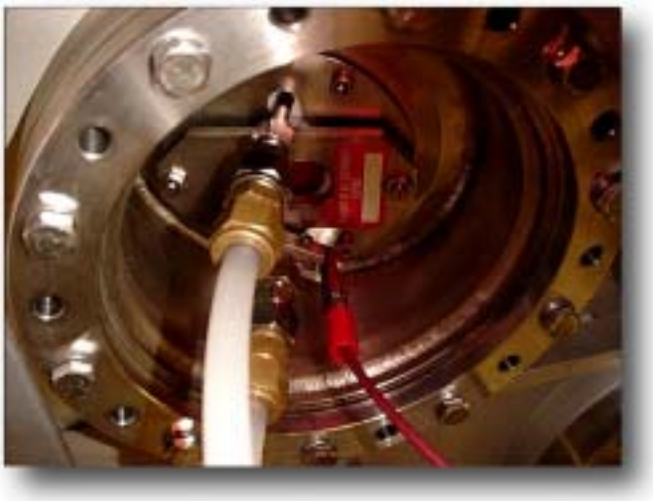
Figure 4-2. Underside of cathode

The researcher had installed the cathode assembly in the equipment approximately a week before the incident and had secured all the electrical connections. He knew that when the equipment was energized the entire bottom of the cathode assembly, including the cooling water connections, was energized. He understood immediately after the shock why it had occurred. Figure 4-1 shows the sputtering unit involved in this event; Figure 4-2 shows the underside of the cathode.

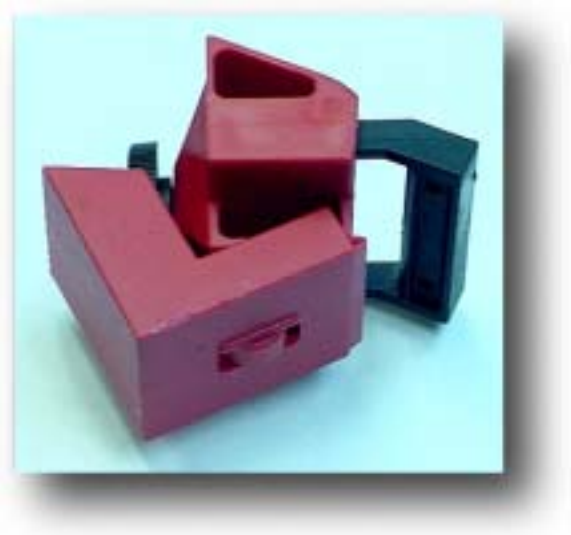
During a critique of the event, critique members learned that the electricians applied electrical tape to shim the handle in an attempt to get the locking device to remain in place and prevent operation of the circuit breaker. Figure 5-1 shows the locking device, which uses a thumbscrew to hold the device in place.

Figure 5-1. Locking device that fell off the circuit breaker handle
