Operating Experience Summary

U.S. Department of Energy
Office of Environment, Safety and Health
OE Summary 2006-06
May 11, 2006

Failure to Install Guard on Table Saw Results in Loss of Finger

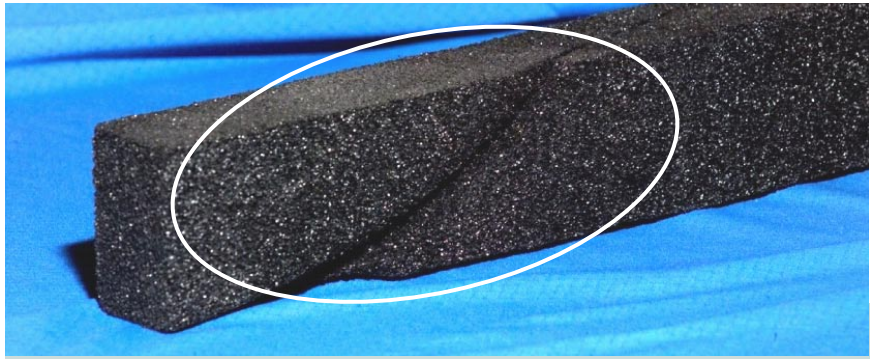
scrap portion (the side where the blade was located) of the foam. As he was completing the final cut, the foam kicked back unexpectedly, and his right hand came in contact with the saw blade. Figure 1-3 shows the piece of foam that the technician was cutting when the accident occurred. (Evidence that the material kicked back can be seen in the photo.)

Figure 1-3. Piece of ETHAFOAM900® post-accident, showing evidence of kickback (circled)
