Visual Resources

3 Affected Environment, Environmental Consequences, and Mitigation

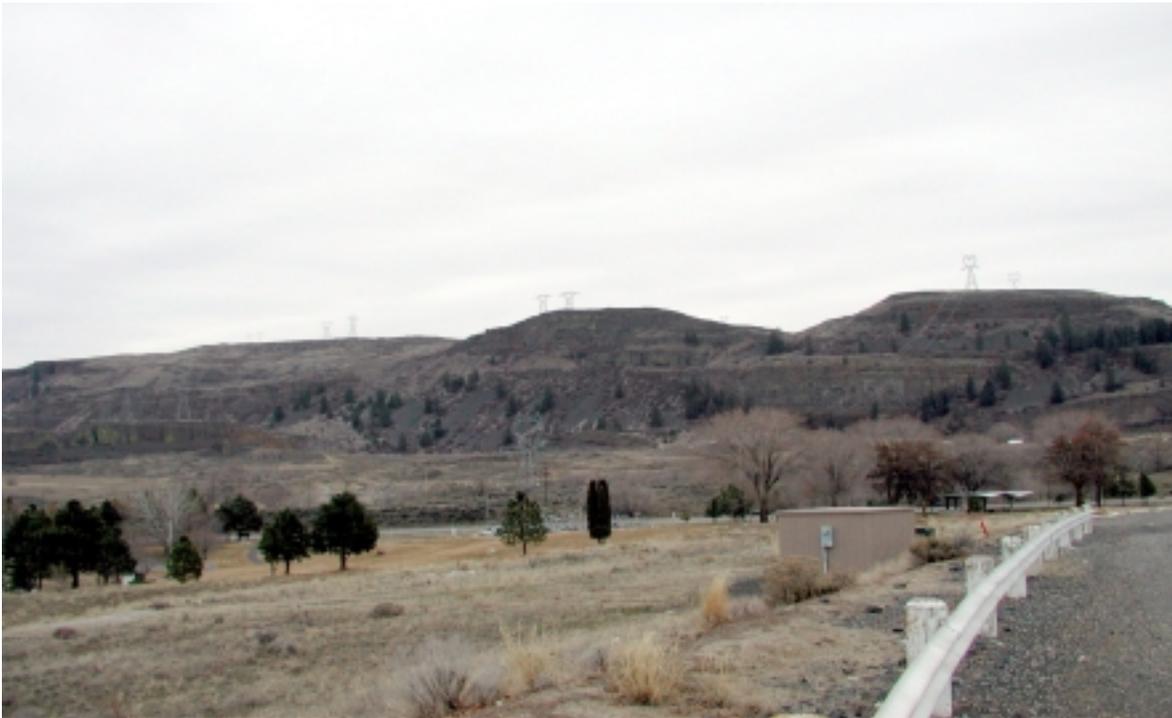
Figure 3-15. Grand Coulee Area (from North Dam Park looking south)

At the west end of the corridor near the Columbia River, terrain is rugged, with large basalt outcrops, steep slopes and canyons. The area is scenic because the landscape is vast and encompasses a variety of landscape features of differing form, color, and texture, including the Grand Coulee Dam and Lake Roosevelt. The City of Grand Coulee is also located here, which was built around the construction of Grand Coulee Dam. Grand Coulee Dam is a major producer of electricity, and there are many transmission lines of different sizes, shapes, and colors that cross the area (see Figure 3-15 and 16).

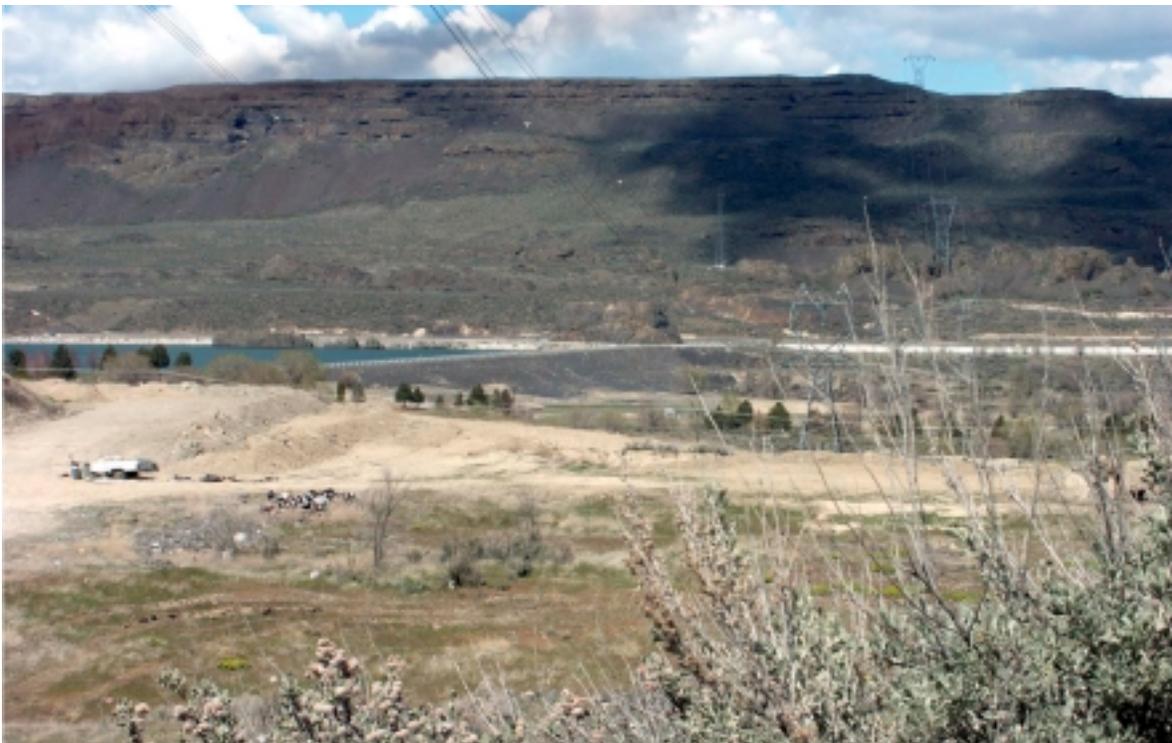
Figure 3-16. Grand Coulee Area (looking north from Delano Heights)

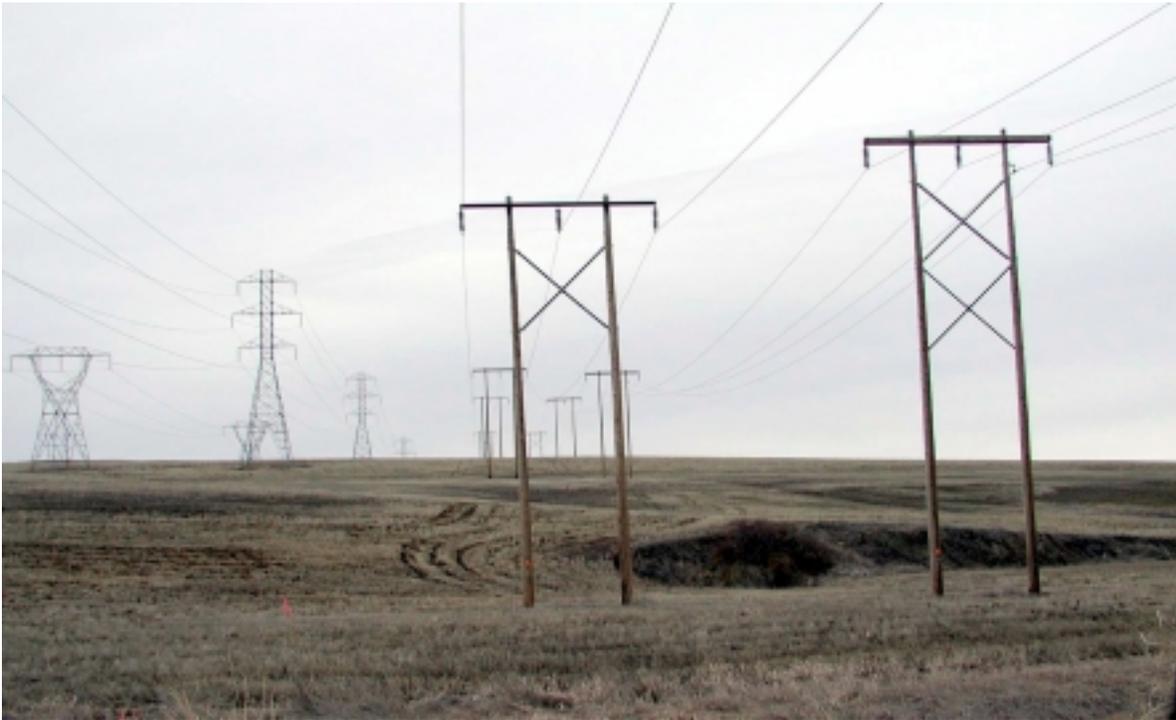
Figure 3-17. Cultivated Area (looking east)

The landscape east of Grand Coulee is dominated by large dryland farms broken in places by intervening drainages (some rugged and forested), rangelands and scrublands. Much of the terrain east of Grand Coulee is relatively flat and rolling farmland that changes seasonally as farmers plow fields, plant and harvest crops (see Figure 3-17). The rights-of-way in this area tend to blend with the adjacent land because crops are grown in the right-of-way. The area is dry and a surface haze often lessens distant views.

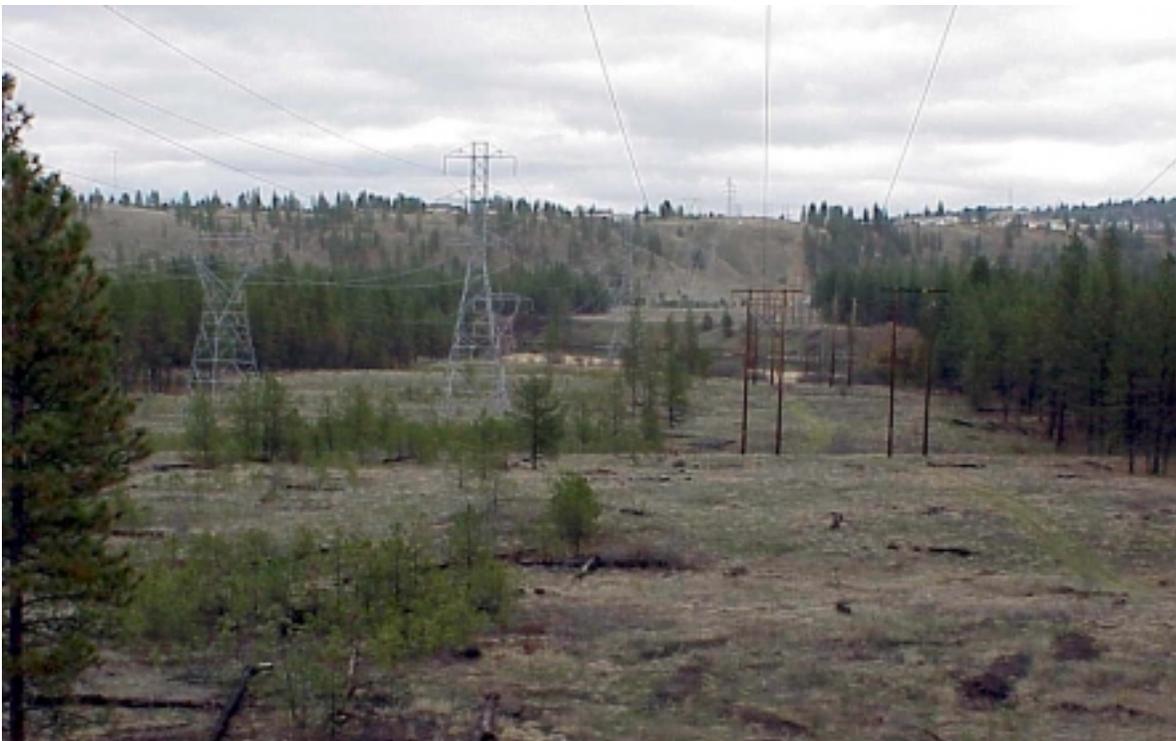
Figure 3-18. Spokane River/Riverside Park (looking east).

The setting in the eastern part of the study area is more urban and varied. It encompasses the scenic Spokane River and adjacent park land; residential, commercial, and institutional areas east of the Spokane River; and an industrial landscape near Bell Substation. The Spokane River, which flows through Spokane, has numerous recreational and scenic opportunities along its banks (see Figure 3-18). The main resource for scenic and recreational opportunities along the Spokane River is within Riverside State Park. The existing Grand Coulee-Bell corridor crosses the park north of Deep Creek. The crossing is visible from Nine Mile Road to the east and Riverside Park Drive to the west approximately between corridor mile 76/8 and 77/6.

The transmission line crossing of the Spokane River would cause moderate to high impacts to viewers depending on viewer location (see Figure 3-28). Most views would be in the middle ground and background with towers *backdropped* or well screened by trees and topography. Motorists using Nine Mile Road would have moderate impacts. Traffic is light but motorists would see the line for 2 to 3 minutes.

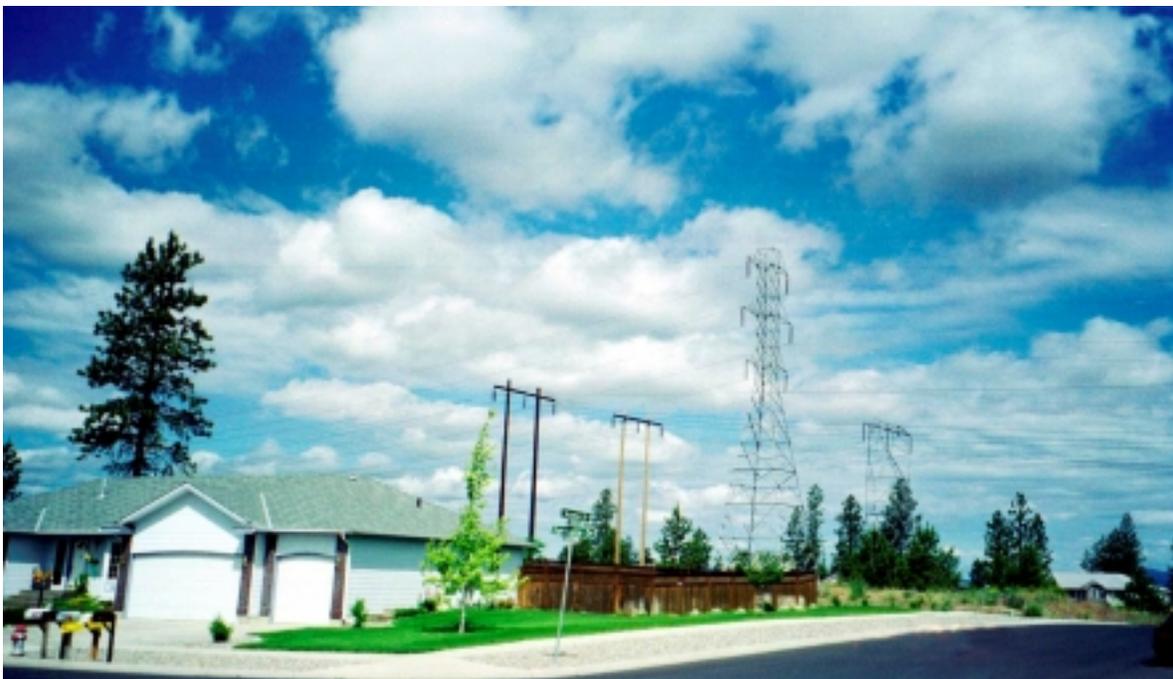
Figure 3-19. Residences Next to Corridor – Indian Trails Area.

Suburban Spokane is hilly and tree-covered, with many housing developments next to the corridor or within view of it (see Figures 3-19, 20 and 21). The corridor is readily apparent in this area because trees have been cleared and/or houses are present up to the edge of the ROW. Along Indian Trail Road between corridor mile 78/2 and 79/2, two subdivisions have been built adjacent to the southern corridor boundary. Lattice steel towers and wood poles are clearly visible from the housing developments. The corridor skirts the northern edge of Fivemile Prairie, with more sparsely developed residential uses in the area, and then descends in elevation toward Whitman College. Continuing east, the right-of-way passes between single-family housing developments and Whitworth College (see Figures 3-22). The northern boundary of Whitworth College campus does not have views of the corridor due to grade changes and screening by trees. On the northern boundary of the corridor between Waikiki Road and U.S. Highway 395 (corridor mile 81/10 to 82/7) single-family homes are present adjacent to the corridor. Those homes immediately adjacent to the corridor have clear views of the existing lattice steel towers and wood pole structures. The corridor passes near another single-family housing development between corridor mile 82/8 and 83/3. Homes in this area are more set back from the right-of-way (there are two intervening Avista 110-kV transmission lines in this area, and trees provide partial screening). Between corridor mile 83/4 and 83/6, the corridor (which consists of just the two 115-kV lines in this area) traverses the Hico Village Northpointe commercial area (see Figure 3-23). Near Bell Substation the land is flat and covered with grass (see Figure 3-24). This is an industrial area with the Kaiser Aluminum plant adjacent to Bell Substation.

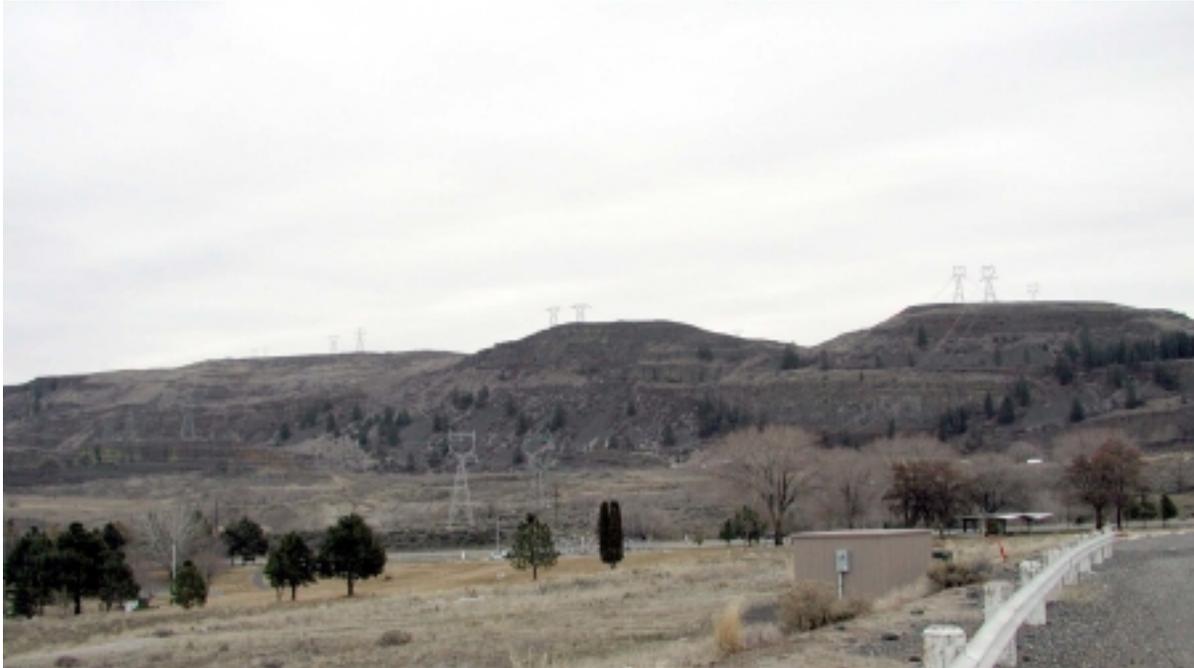
Figure 3-25. Grand Coulee Area With Photo Simulation (from North Dam Park looking south)

Transmission lines are commonplace in the Grand Coulee area and they are a major element of the visual setting. There are many transmission lines that vary in size, shape, and color and extend in many directions. The new transmission line would be a relatively small addition to the setting. The new line would extend across North Dam Park, an existing landfill, and SR 155 near single-family housing. Residents in and around Grand Coulee, tourists, motorists and pedestrians would be able to see the transmission lines. The line would be in the immediate foreground of users of the park, which may adversely affect their experience. The new towers, though large, would be consistent with existing conditions. Overall, the impacts would be low to moderate because the large number of the existing lines has altered the visual character of the existing landscape (see Figures 3-25 and 26). However, depending on tower placement, the line could intrude on a viewshed that encompasses Grand Coulee and the Columbia River from an archeological site in the area. If such visual intrusion occurs, the level of impact would be high.

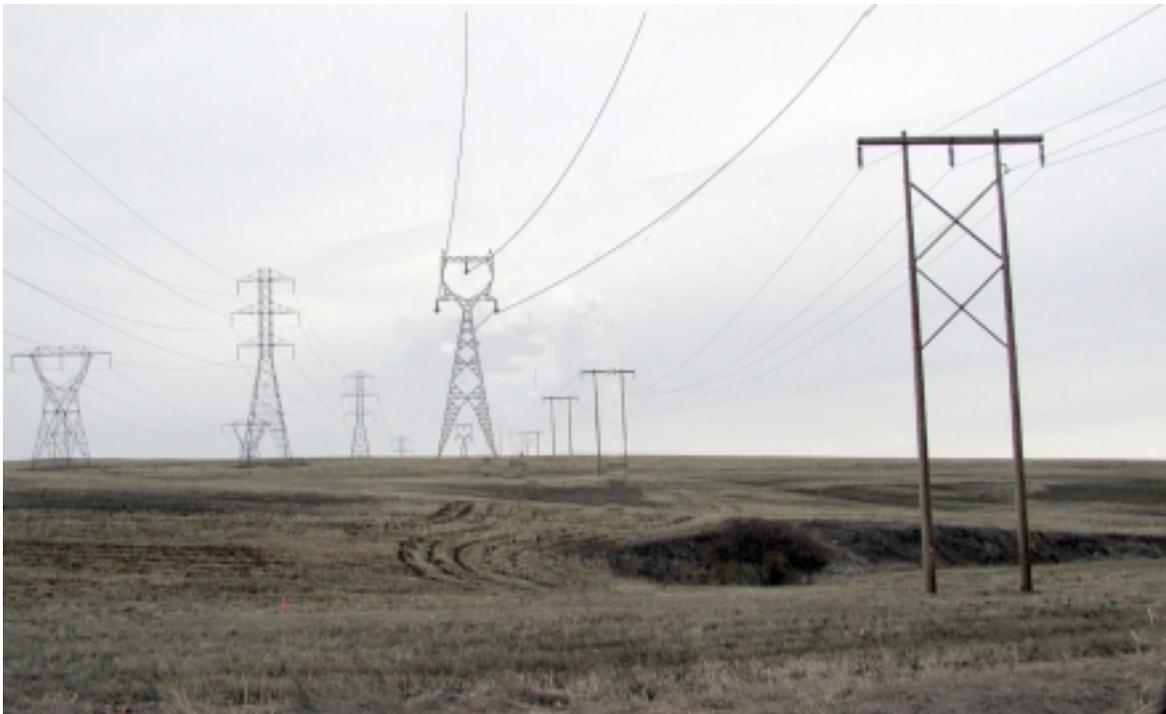
Figure 3-27. Cultivated Area with Photo Simulation (looking east)

Between corridor miles 6/4 and 6/5, cultivated fields begin and continue to corridor mile 68/9, interrupted only by intervening drainages, woodlands, and scrublands, especially in the Bachelor Prairie/Hawk Creek area, where rugged terrain prevents farming. Though most of this segment is isolated, it does parallel and/or cross local and county roads. Most viewers would see the line briefly and/or in the background. Because most views are from afar, the expansiveness of the landscape would diminish the scale of the large towers and would absorb the towers into the landscape. An exception may be during periods of low sun angles in the early morning and late afternoon. Unless mitigated, the sun reflecting off the towers, conductors, and insulators would increase visibility by several miles. A representative view of the corridor traversing agricultural land is shown on Figure 3-27.

In the agricultural land the right-of-way would not be visible. In the non-agricultural areas, vegetation is sparse and canyons can be spanned with minimal clearing. These areas are isolated with few viewing opportunities. Overall, the level of impacts for this segment would be low because the segment is isolated, few people would see the line because there are few residences and roads are lightly traveled, and it would be in an established corridor.

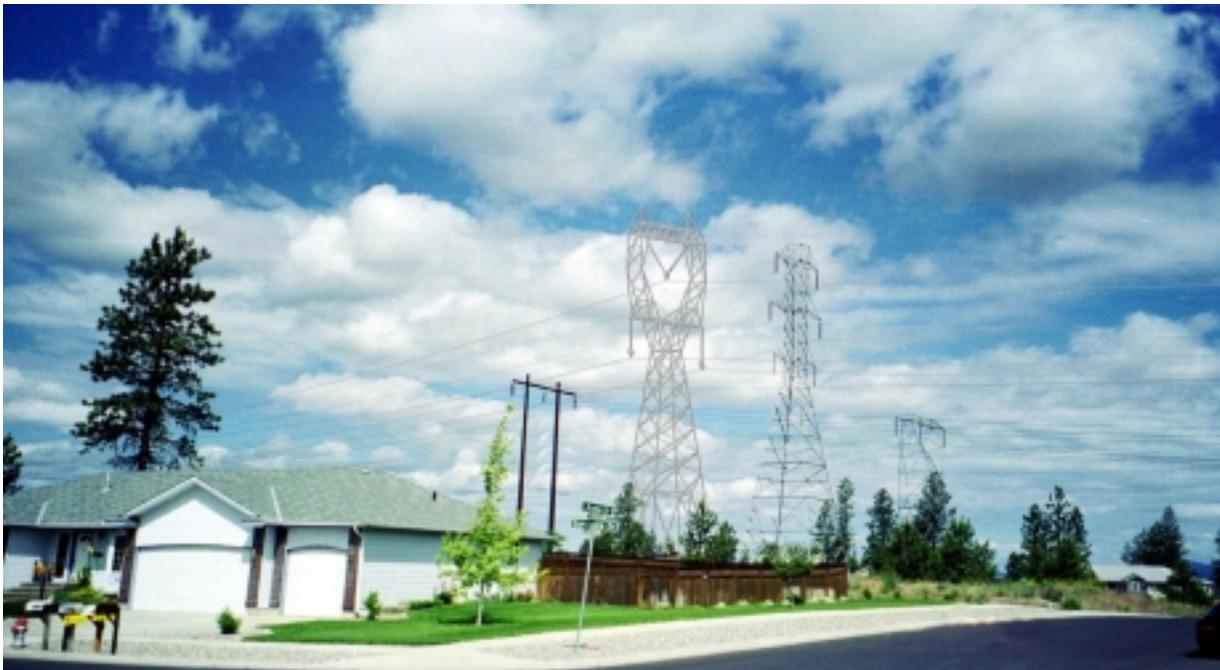
Figure 3-29. Residences Next to Corridor with Photo Simulation –Indian Trails Area

Between towers 77/7 and 81/8, the line is next to housing developments (see Figure 3-29) and/or visible to many residents with middle ground and background views. East of Nine Mile Road the corridor passes immediately adjacent to a housing development between corridor miles 78/1 and 79/2. In this section, the line would remain a prominent feature and be visible to many viewers, with impacts ranging from moderate to high. In some areas, such as near Five Mile Road, residents would have panoramic views of the new line because towers and conductors would occupy most of their view. The level of impacts would be high in these areas.

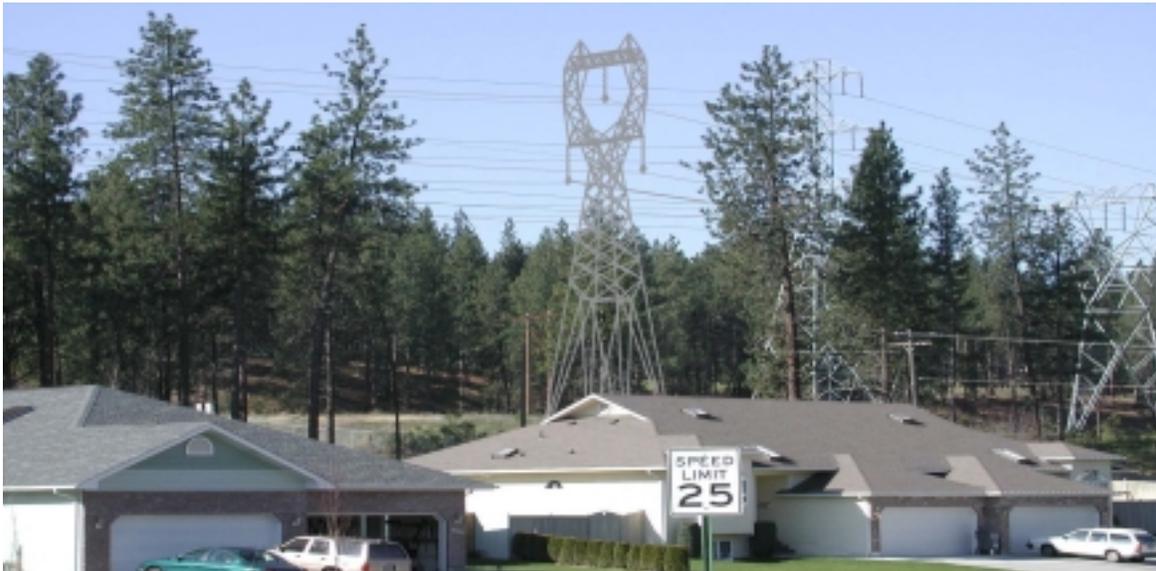
Figure 3-30. Residences Next to Corridor with Photo Simulation – Brentwood Area

Crossing Waikiki Road and continuing to corridor mile 83/3 the new line would be close to and in direct view of many residents (see Figure 3-30). The northern boundary of the corridor is adjacent to single-family homes between corridor miles 81/10 and 83/1. The size of the 500-kV line and conductors, in relation to nearby objects, would be more dominating. Residents nearest

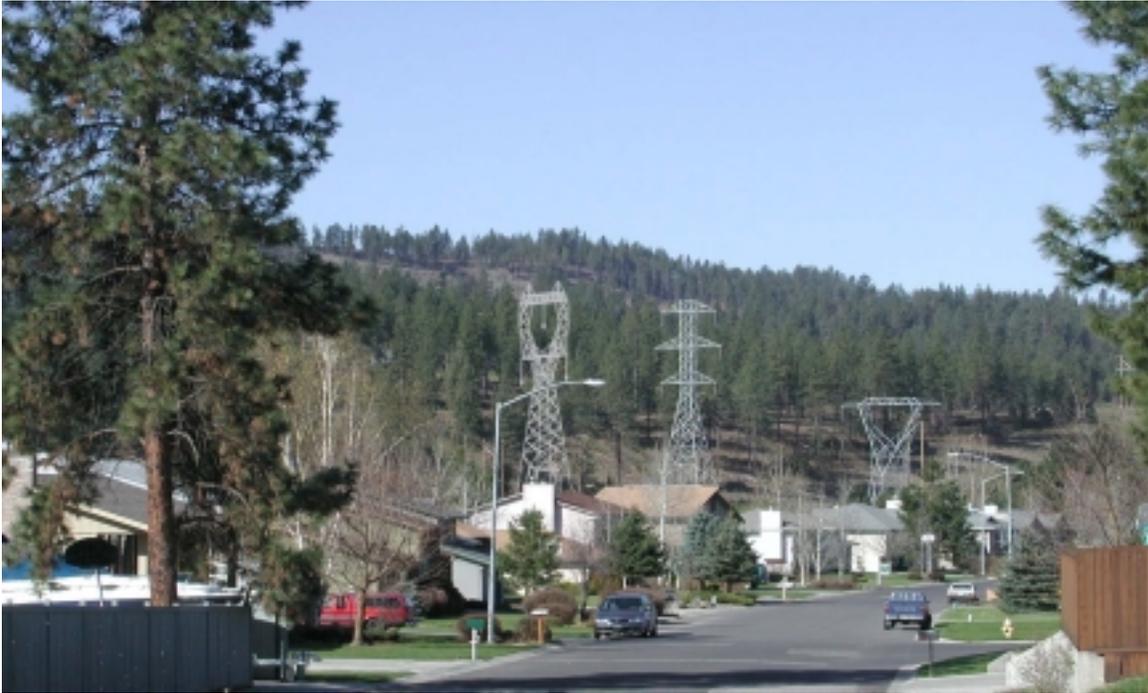
Figure 3-31. Middle Ground View From Subdivision with Photo Simulation

to the corridor would likely experience high impacts, but as people become accustomed to the new line, their awareness of it would moderate over time. Most residents beyond about 500 feet would have low to moderate impacts because much of the line would be blocked from view by other houses or vegetation (see Figure 3-31).

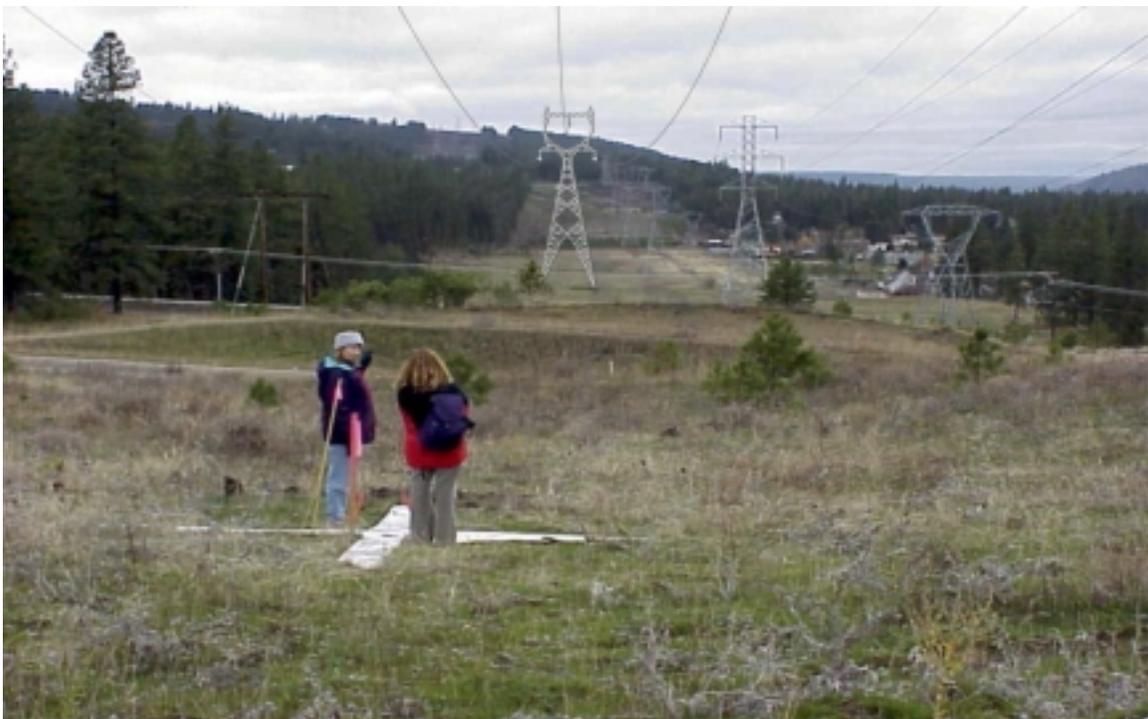
Figure 3-32. Whitworth College Area with Photo Simulation

Between corridor miles 82/1 and 82/6 the corridor runs adjacent to the northern boundary of Whitworth College (see Figure 3-32). The northern boundary of the college slopes down to the corridor and is heavily vegetated. The new transmission line would have a low impact to the college given the amount of vegetation and topography. At corridor mile 83/1 the corridor travels southeasterly towards Bell Substation. Between corridor miles 83/1 and 83/3 the corridor passes close to existing single-family homes. The impact to these homes would be low to moderate depending on the amount of screening of the line from existing vegetation.

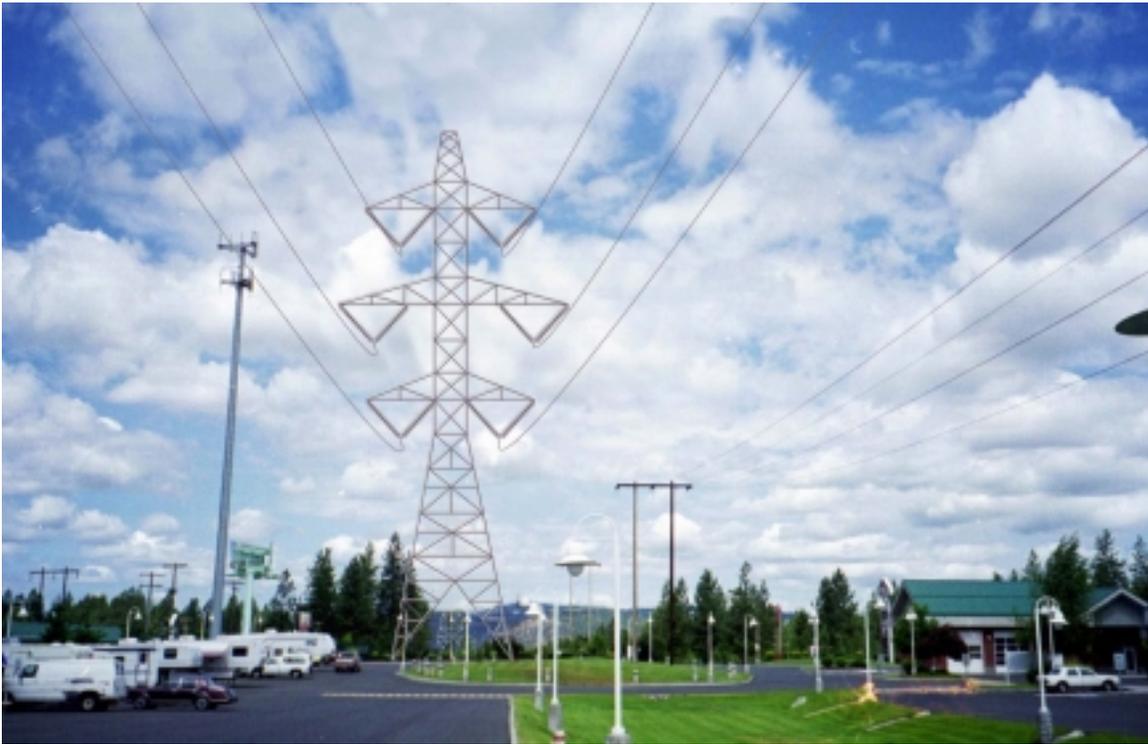
Figure 3-33. Commercial Area with Photo Simulation

Between corridor miles 82/6 and 83/7 the line would be less visible because the flat terrain and screening from trees and buildings would limit views from off the right-of-way. With use of double-circuit towers between corridor mile 83/1 and 83/6, the transmission line would contrast with the existing corridor to a greater extent, and would be more visually apparent to viewers. Between corridor mile 83/4 and 83/6 where the corridor traverses across a commercial area that also supports RV use, the transmission line would be readily apparent in the foreground (see Figure 3-33). In this area, the double-circuit lattice steel towers would be on the southerly side of the corridor. Impacts would be moderate in this area. Commuters on U.S. Highway 395 and U.S. Highway 2 would have views of the line but impacts would be low to moderate because views would be brief, with other distractions such as traffic, road signs and vegetation competing for viewer's attention.

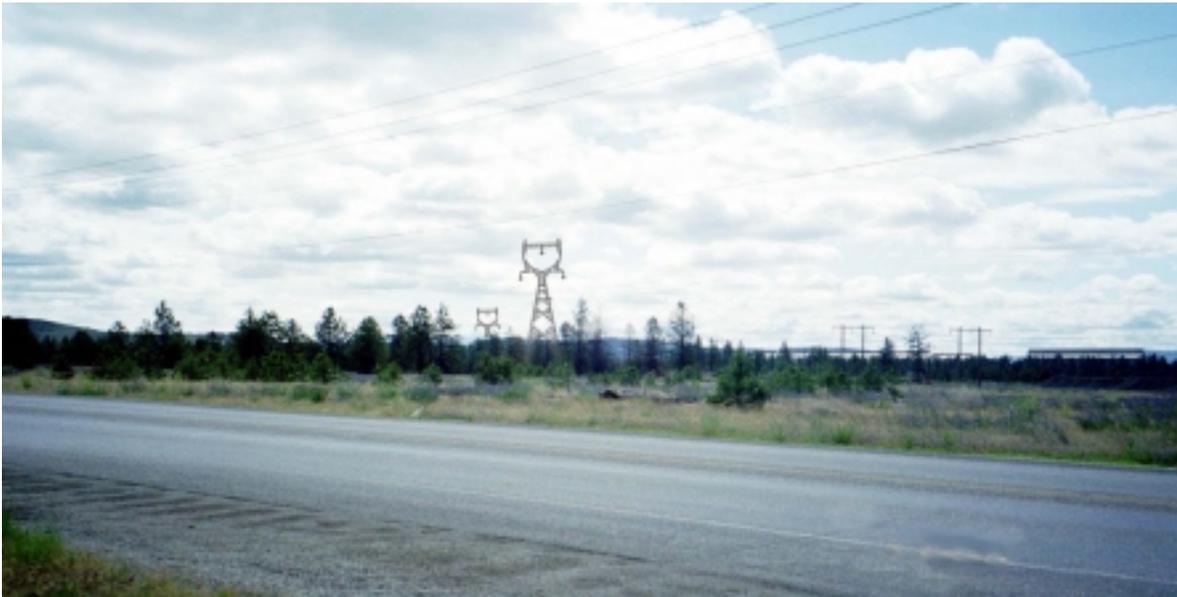
Figure 3-34. Industrial Area with Photo Simulation.

Impacts would be low from corridor mile 83/6 to Bell Substation. This is an industrial area that has been modified by many lines entering Bell Substation (see Figure 3-34).
