FIGURE III-5. Flow in Tuscaloosa Aquifer

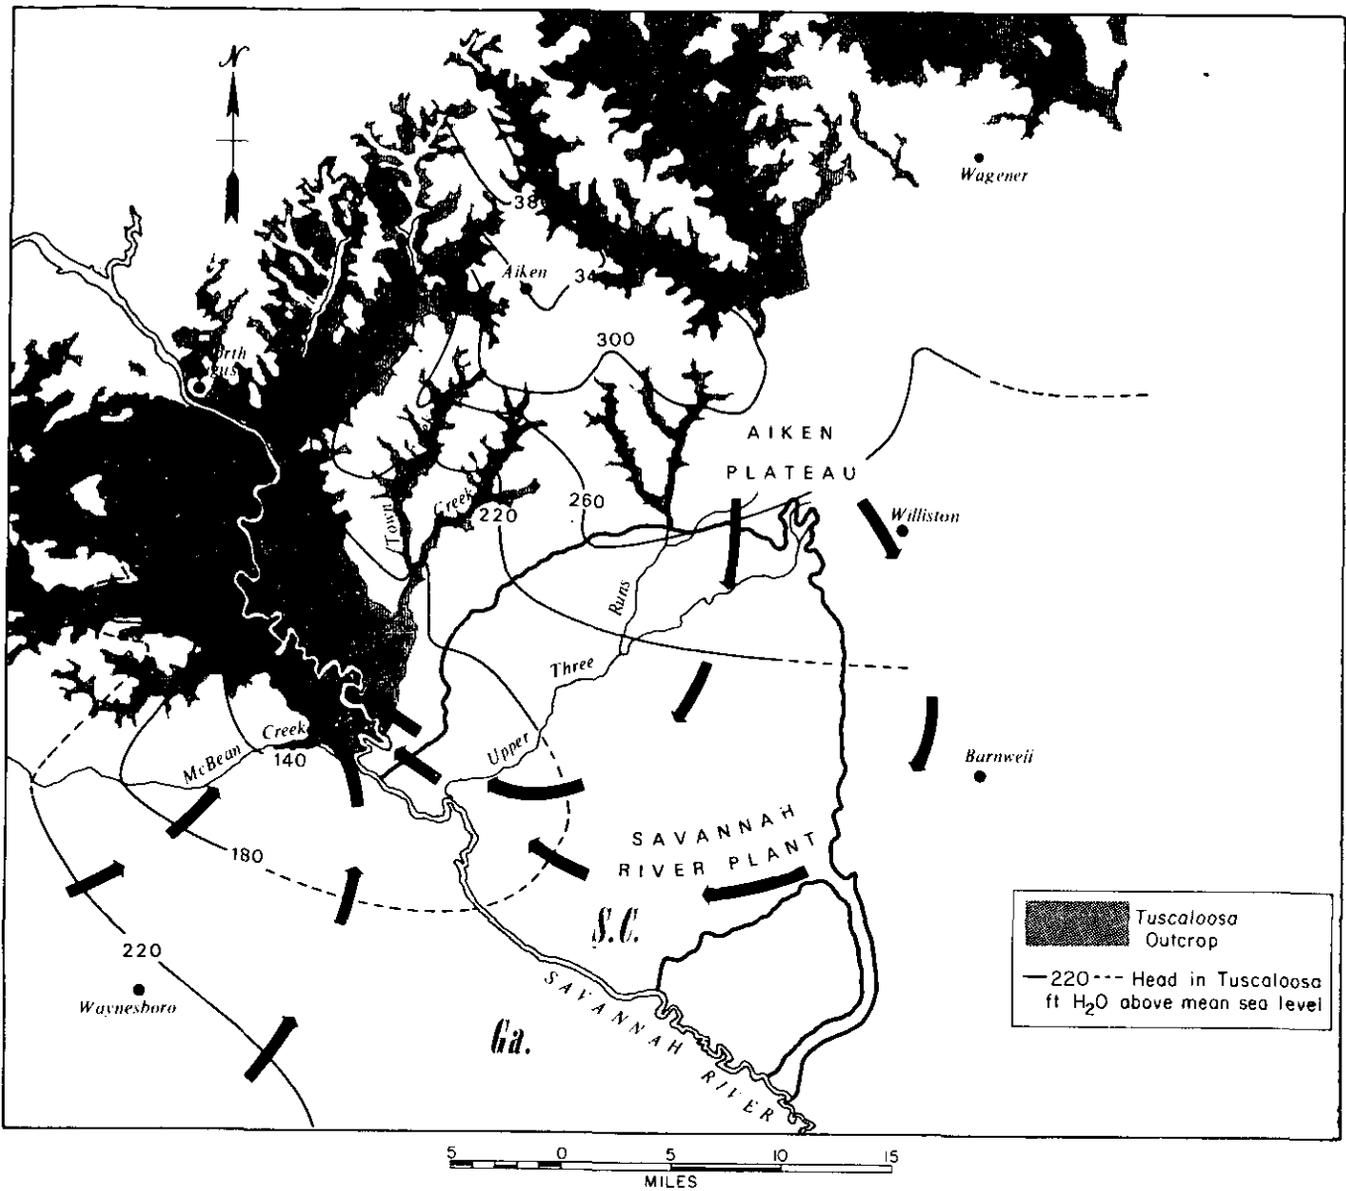
(Ongoing hydrographic measurements indicate that this flow pattern has remained the same under the SRP site since the early 1950's.)
